Much of the restoration work completed by the NRF Field Carpenters and Millworkers is concealed by a beautiful fresh coat of paint. Weeks of assessment and construction takes place before a paintbrush touches one of our historic homes. The repairs to the 70+ Preservation Properties are as specialized as the homes themselves. Everything needs to be specially crafted and fitted into the existing building fabric. The process is methodical and meticulous — but rewarding in the final result. Thank you to the NRF Preservation Team **Alyssa Lozupone** (Dir. Of Preservation), **Margaret Back** (Preservation Projects Manager), **Joe Chretien** (Preservation Crew Supervisor), the **NRF Carpentry and Painting Crews**, and **Erica Kelley** (Tenant Liaison).

Hello Friends,  
As summer in Newport, Rhode Island heats up, the restoration efforts of the Newport Restoration Foundation keep to the scheduled work. This 2024 season, NRF will work on 6 of our preservation properties. A great deal of detailed carpentry work is required to repair parts of a house before any finishing applications can take place. Once the work at a job site is complete, the fresh coat of paint complements the underlying c

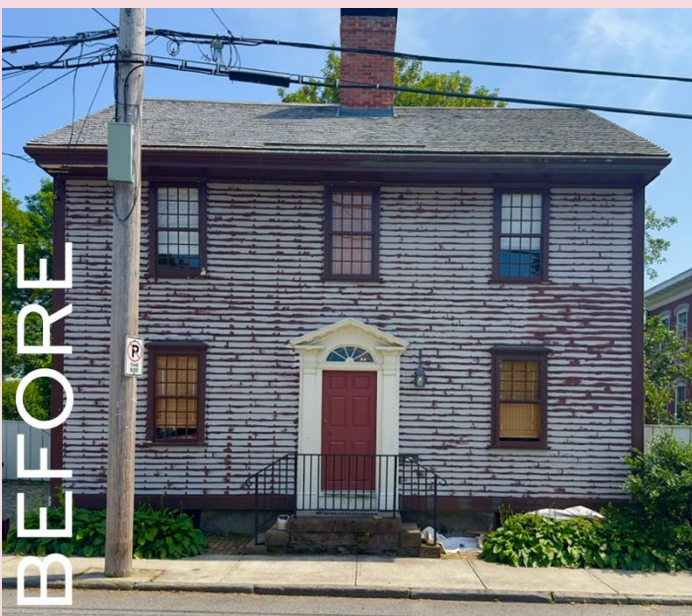
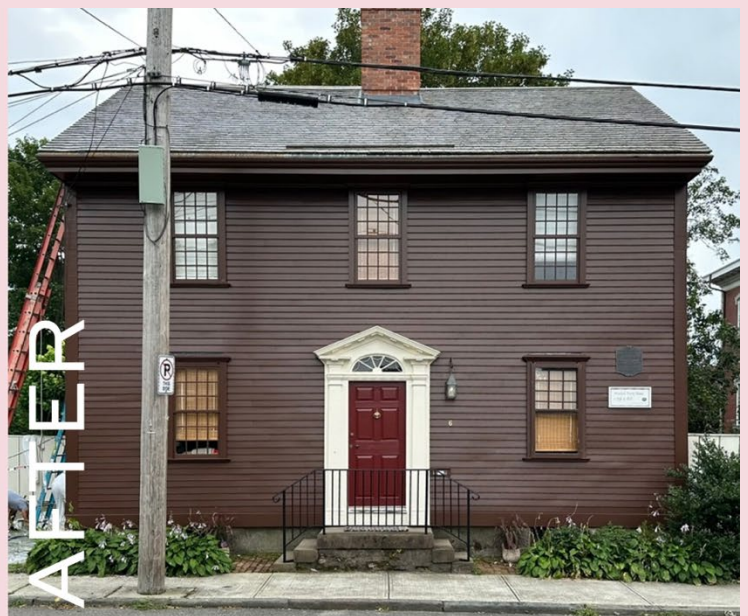
The BEFORE and AFTER photographs of **6 Elm Street** show clapboard replacement in process and then the finished exterior with a new coat of paint.

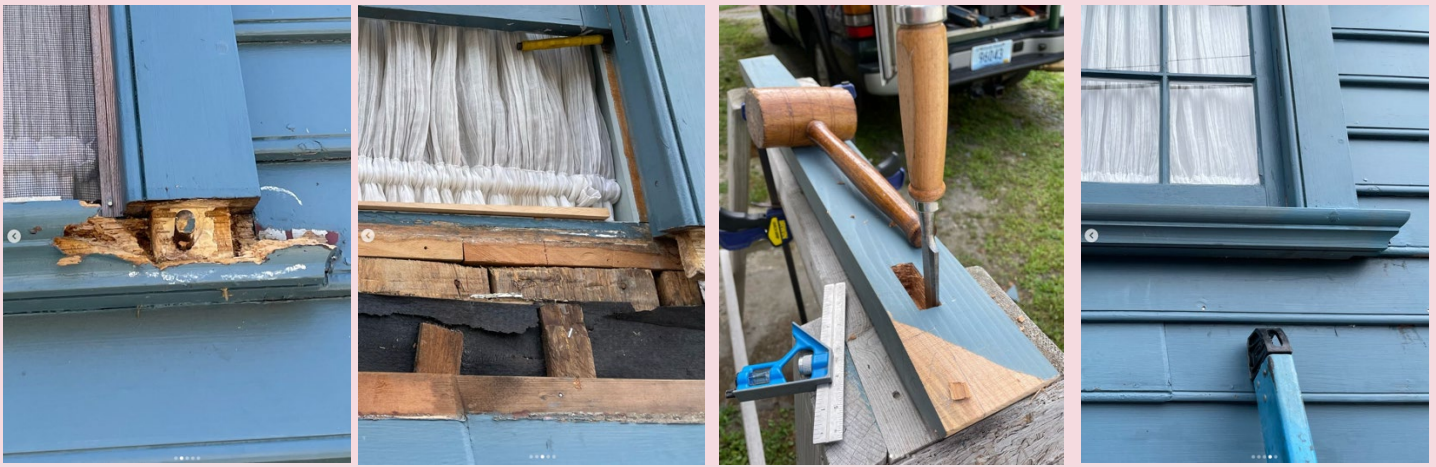
A windowsill at **4 Elm Street** was showing signs of rot. Upon closer inspection by our preservation team, it was determined that a complete replacement was required. Often, a good deal of the surrounding exterior sheathing and molding are removed to complete a full assessment of the current conditions. Once the extent of the repairs is determined, the carpentry crew craft a custom replacement. After the millwork has been restored, the painting crew gets to work, and the repair is seamless! Special thanks to **Mike Plumer (field carpenter)** for his **documentation and photographs.**

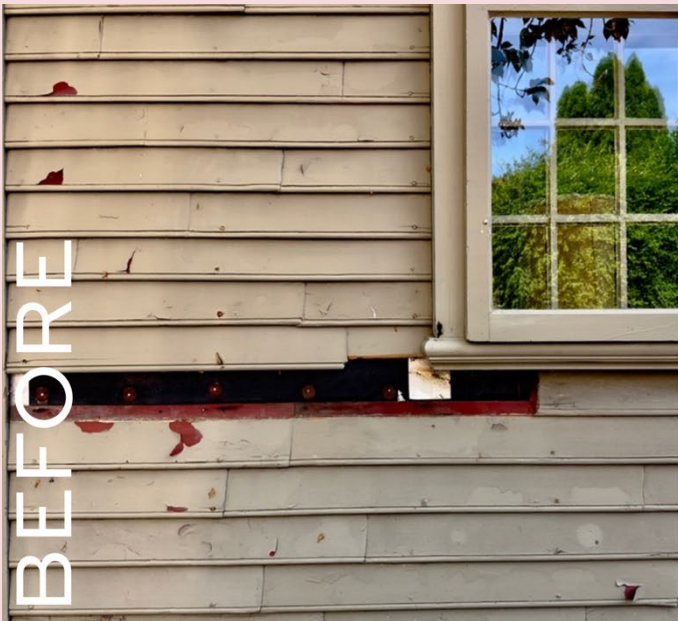
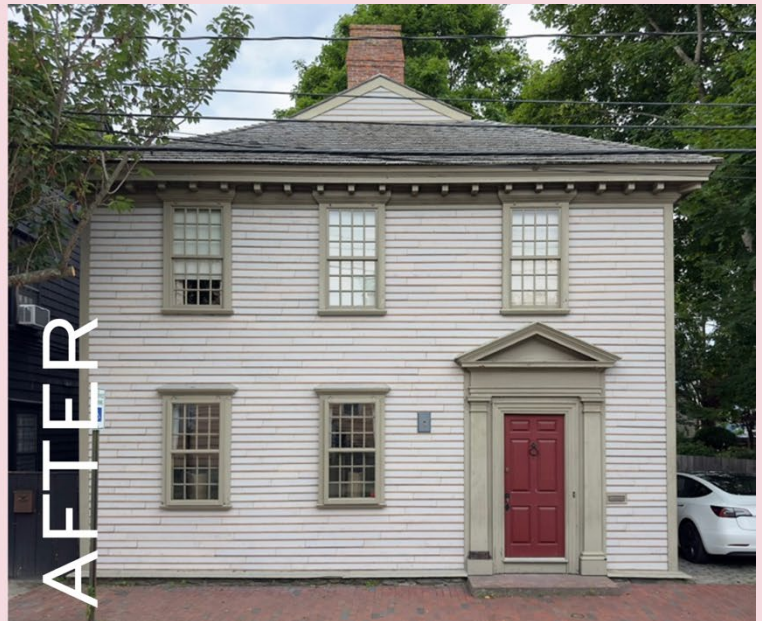
The exterior clapboard at **67 Thames Street** needed restoration. The process involved the removal of the existing failing clapboard and vapor barrier and the installation of new milled clapboard. To highlight the historic character of the colonial house, the new clapboard is attached using visible brass nails. The house now is ready for the next phase of the restoration: paint.
